Manhole Inspection Summary

Manhole # S33MM1004MH

Insp Date: **4/2/07 9:02 AM**

Location Address: **COLD SPRING LN**

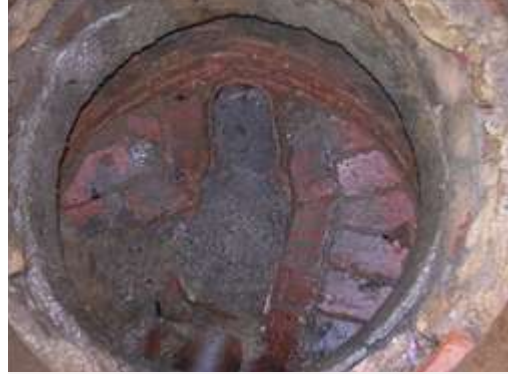
Top View

Corbel infiltration. Channel debris.

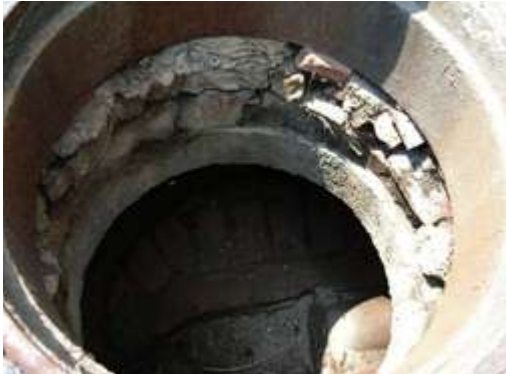
Defect

Frame leaks. Adjustment deterioration, loose brick and infiltration.

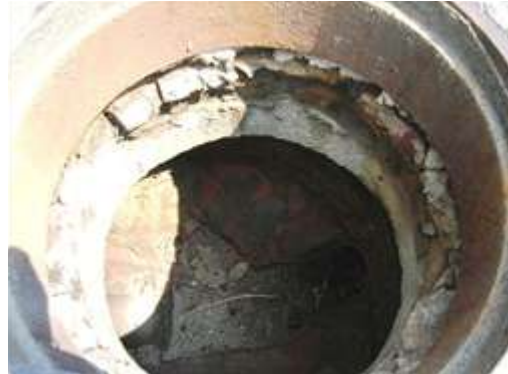
Defect

Frame leaks. Adjustment deterioration, loose brick and infiltration.

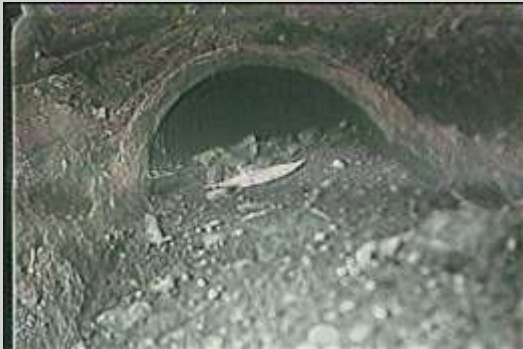
6 in. Circular Gravity Sewer Pipe Out @ 12 O'Clock

Deposits: ☐ None ☒ **Mud** ☐ Sludge ☒ **Debris** ☐ Grease

Silt Depth: **3** (in.) Deposits Extent: **Heavy**

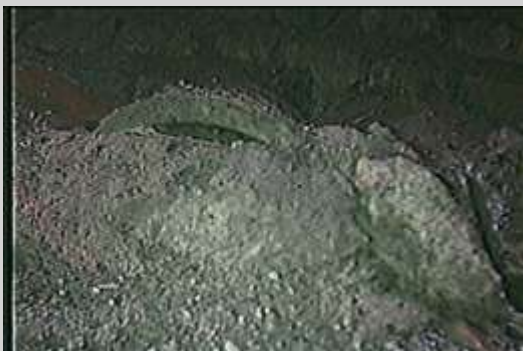
Pipe In @ 6 O'Clock

Plugged.
